Dam ID: KA-0103 H1 00103
Aepo Reservoir

Inspection No: _____
Date: 03/20/2006

STATE OF HAWAII - DLNR
VISUAL DAM SAFETY INSPECTION SHEET

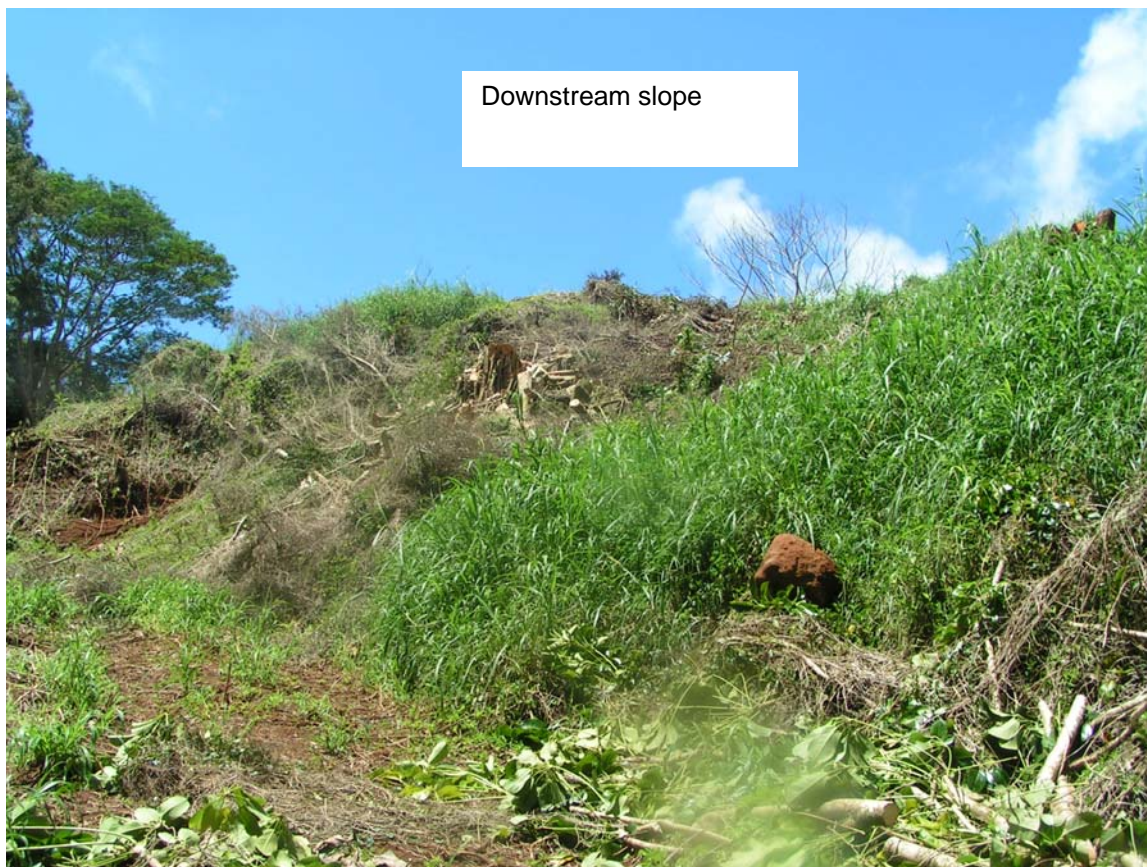
Downstream slope

- The slopes should be clear and visible for inspection. The existing trees have been allowed to grow so large in some cases that there is concern that seepage and piping (i.e. internal erosion) along root systems may develop. There is additional concern that cutting and killing the trees will lead to rotten roots and greater potential for such seepage and piping. A more in depth evaluation of the condition should be performed to determine how best to remediate the condition.

-. A path or roadway along the groins, the toe and to the outlet discharge point should be cleared and maintained to facilitate periodic inspection, maintenance, monitoring of seepage conditions, and remediation, if required.
